HOME INSPECTION REPORT

123 ANYWHERE LANE, SPRINGFIELD

06/26/2013

Work Request: Pre-Purchase Inspection.

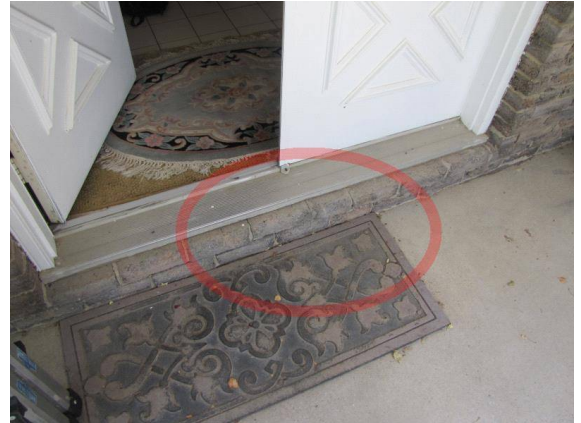
Brick/Stone: Loose exterior wall brick(s) could eventually fall out.
[below front door] Recommend repair.

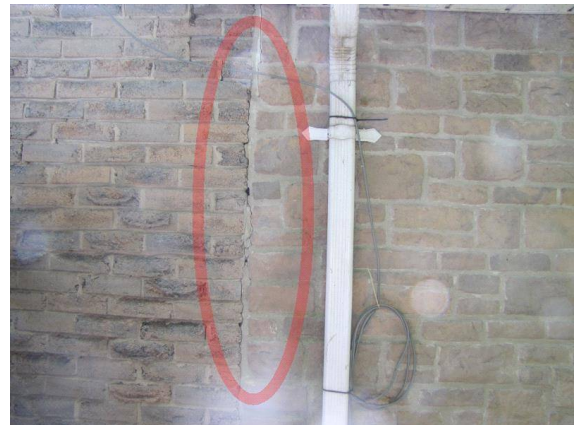
Exterior brick/stone wall cladding vertical crack(s).
[right side between original house and extension]
Seal accordingly to prevent future water
penetration.

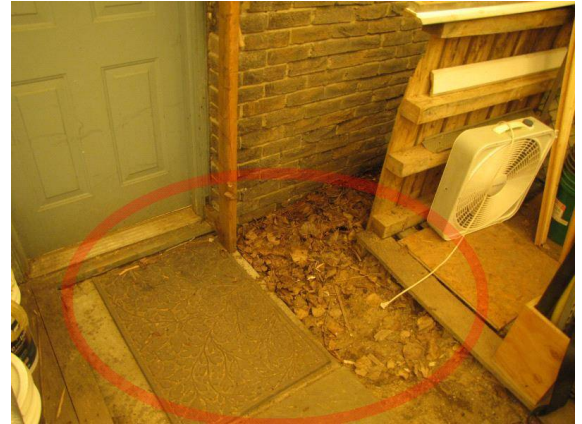
Surface Grade: The slope of one or more surfaces (ie. grade, patio, stairs, walkways, driveway, platform) may not effectively direct water away from the building and could lead to foundation water penetration of below grade structures. [right side of garage] Recommend repair.

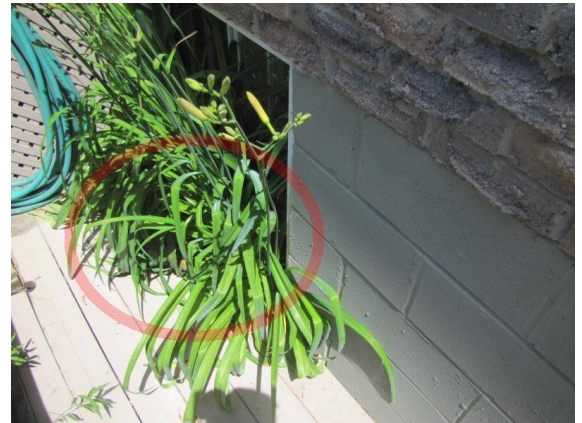
Window sill may be too close to the grade where it may come in contact with ground moisture, rain and/or snow build up. [basement windows at rear and left side] This could result in foundation in window damage and/or water penetration. A minimum of 6" is advisable. Also, if destructive insects (ie. termites, carpenter ants, etc.) are present in the area, this may be providing an access point into the building. Recommend repair.

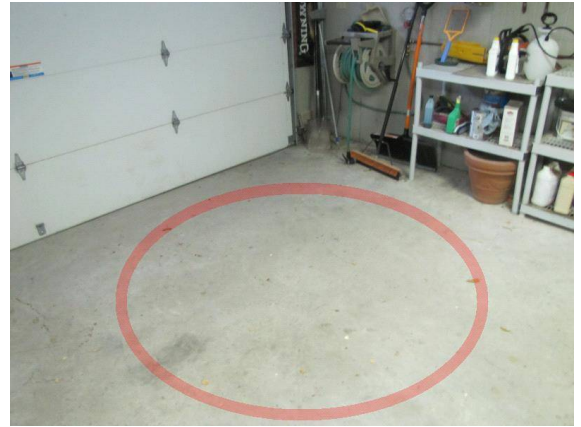
The slope in the garage floor may not effectively drain water away from the building. Water could collect in this area and penetrate the foundation through the seams.

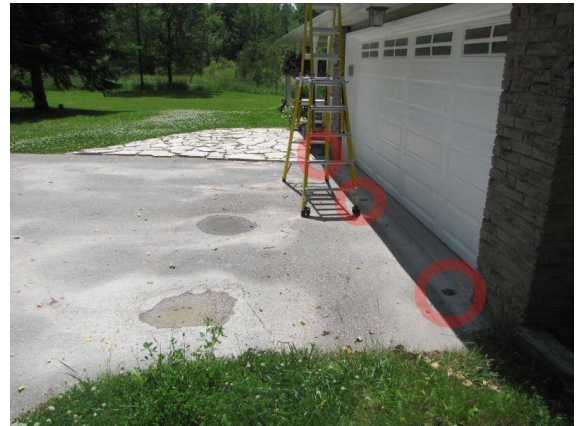
Unknown below grade drainage pipe noted at front of garage. It can not be determined if this pipe will drain adequately and discharge the water away from the house. If these pipes are connected to the house sanitary or septic drainage systems, water leakage or sewer backup may occur. Confirm location and performance of below grade drainage and change to on grade drainage if required.

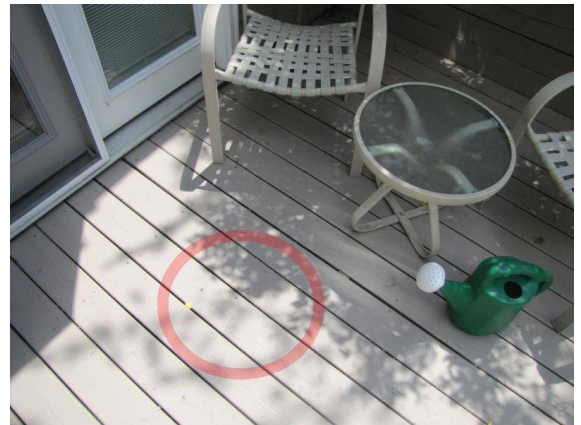
Drainage maybe missing at the base of the exterior basement walkout. Water could collect in this area an penetrate the building through the door. Inquire with vendor regarding known history of problems with this area or item. Recommend Install if not present.

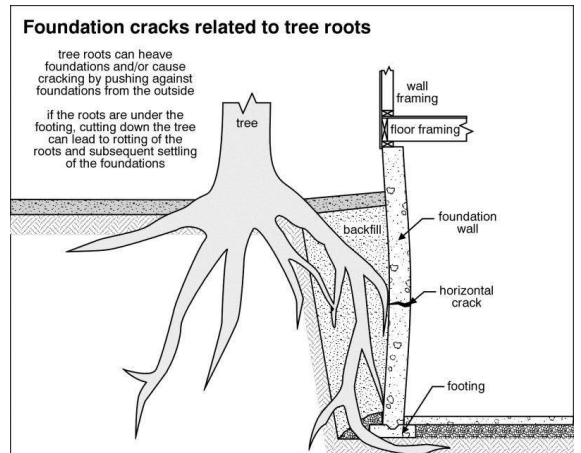
A tree located close to structure may have an invasive root system which could result in foundation structure damage. [rear left] Recommend Removal

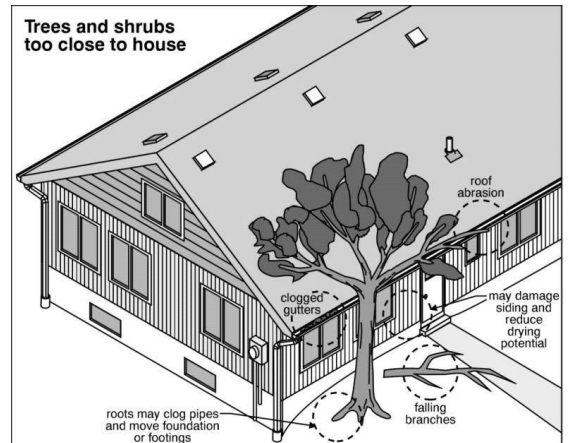
Tree limbs appear to be too close to the building may cause damage to the roof, walls or other surfaces. Also, they may be used by small animals such as raccoons as an access point to the building attic structure. [left and right sides at rear] Recommend Removal

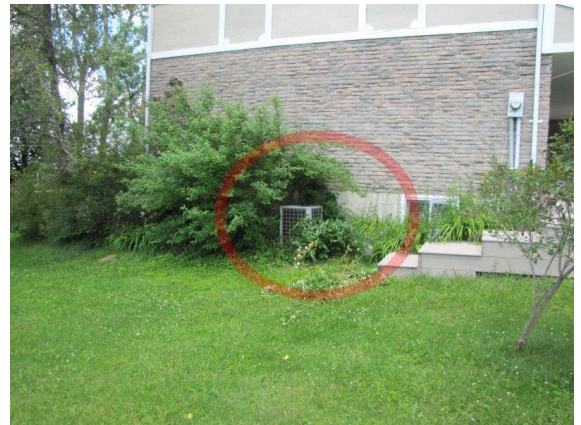
Excessive foliage located too close to the cooling/heat pump appliance will reduce the efficient operation of the unit as well as the life expectancy. Recommend repair.

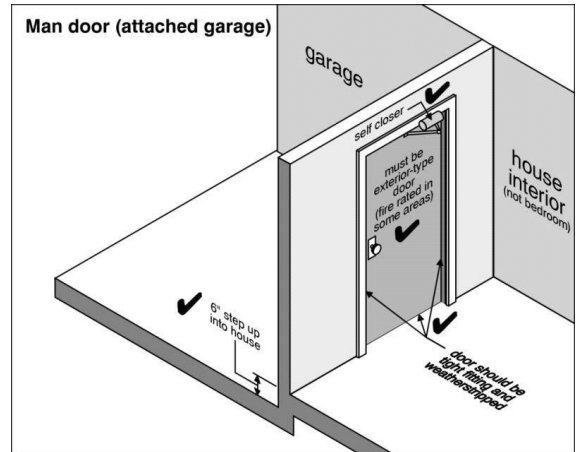
Exit Doors: The self-closing mechanism required to completely close the man door from the house into the garage is missing. Carbon monoxide could potentially enter the house when a vehicle or exhaust generating equipment is running in the garage. Recommend Install

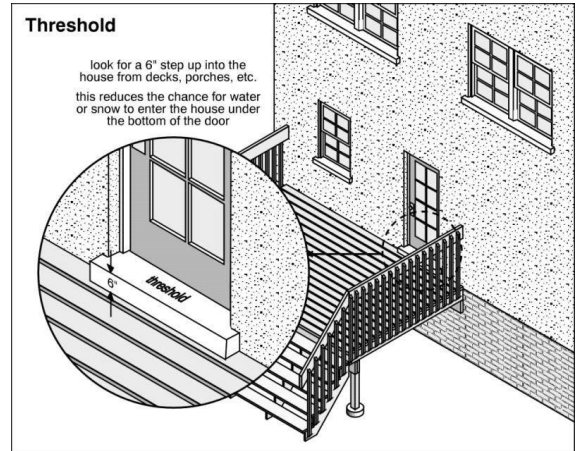
The height from the exit door sill to the external landing (ie. deck, stairs) may be too low to prevent water penetration. [rear sliding door onto deck] Keep clear of snow during the winter

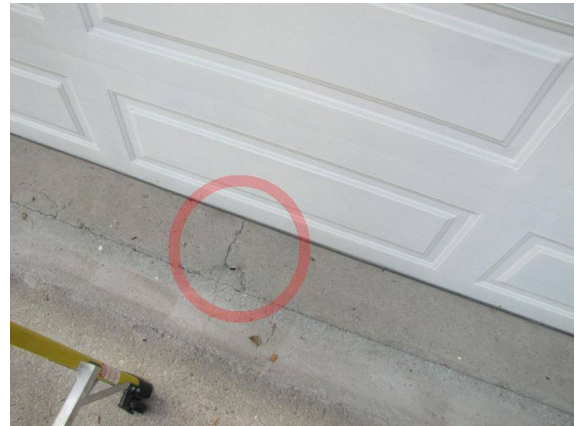
Garage Door: Crack in the garage door sill. Seal portion of crack exposed to elements to prevent further damage.

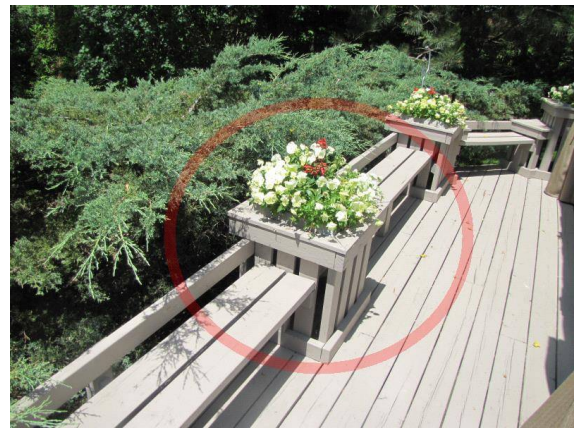
Guardrail spindle design may not prevent climbing of the guard. This condition is a potential safety hazard, particularly for small children. [rear deck - some areas] Recommend repair.

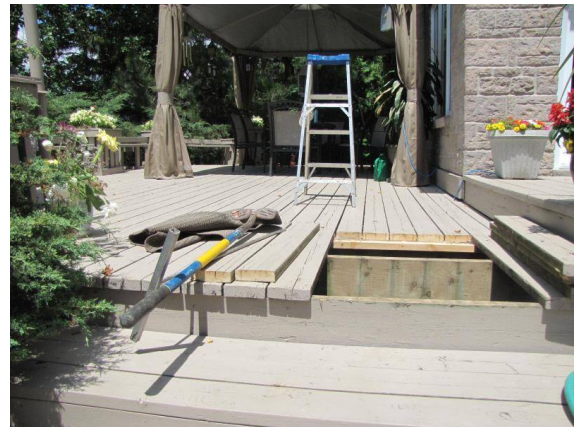
Platform: The platform has shifted in position. [The deck has shifting position and appear to be settling in some areas] Monitor this item for continuing changes in condition which may indicate the need for further evaluation by a deck specialist.

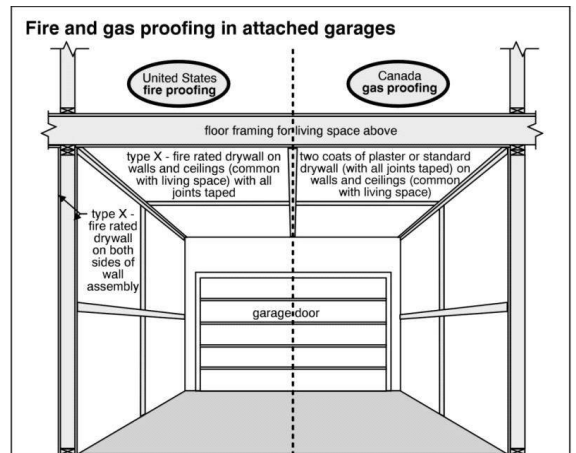
Visible openings or holes in the garage ceiling and/or walls leading to the building interior could allow vehicle carbon monoxide to enter the house. [areas above drop ceiling into garage attic are open to the attic of the extension]

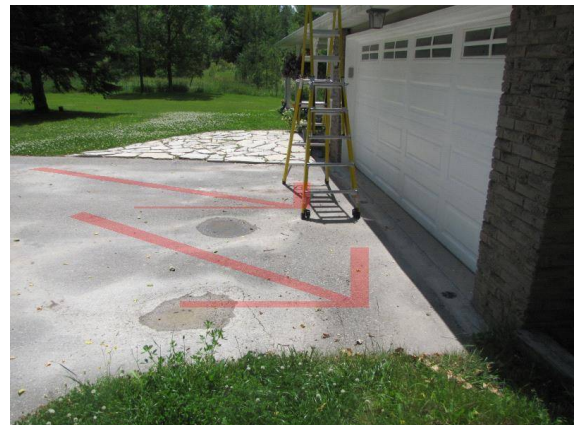
The driveway slope may not adequately direct water away from the house structure. Water infiltration and damage may occur as a result. Ensure that drain in front of garage functions adequately under heavy rain and snow conditions

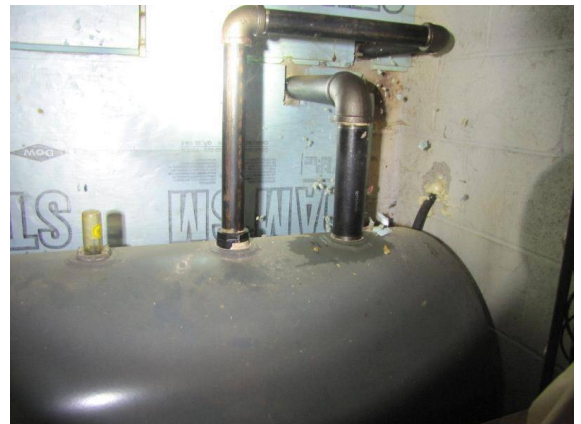
The unknown age oil tank may cause an insurance company to refuse coverage. Confirm eligibility prior to finalizing the purchase agreement.

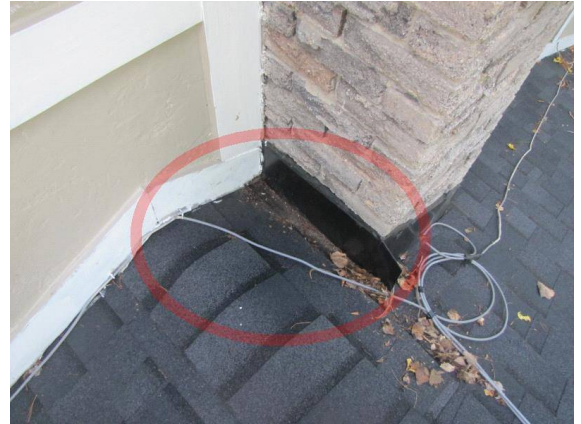
Flashing around chimney may not adequately direct water around the chimney. [garage roof at original house chimney] Water leakage may occur. Recommend repair.

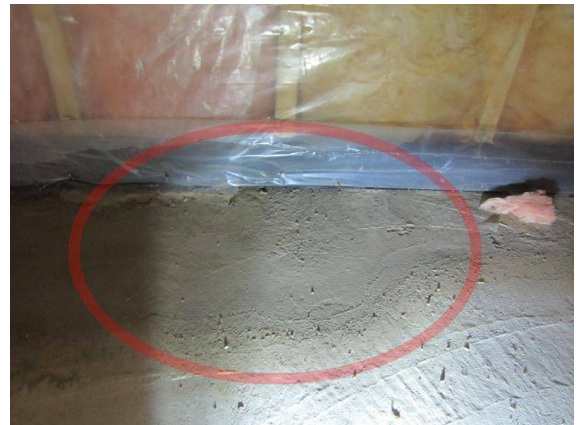
Water marks or similar signs suggests a previous occurrence of water penetration through the foundation wall. [crawlspce - right side] Continued water penetration may be possible if the source of the water has not been determined and corrected. Monitor this item for continuing changes in condition which may indicate the need for further evaluation by an specialist.

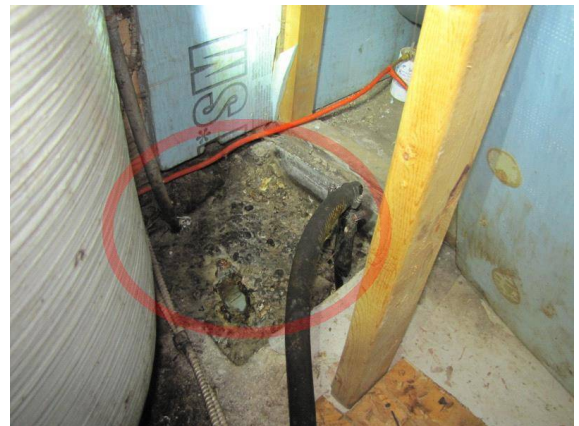
Foundation Floor: Active water penetration suspected from the foundation floor. [front mechanical room floor] Seal accordingly to prevent future water penetration. Continuation of this condition could lead to water damage. Continuation of this condition may lead to mould growth, Consult a basement water proofing specialist for further evaluation and recommended action.

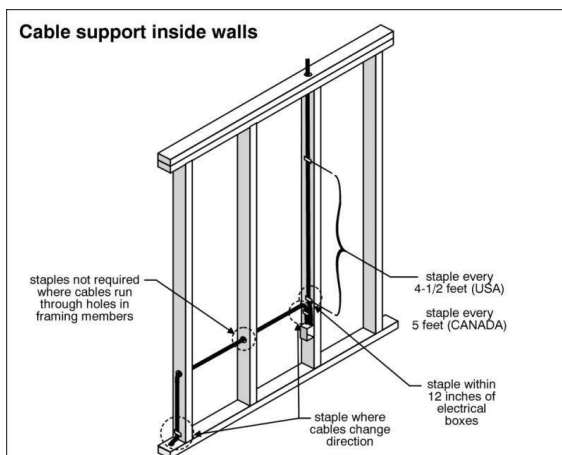
Branch: The electrical branch wiring is not properly secured along the path of its installation. Fasten at least every 5' along studs or joists and where cable changes direction. The electrical branch wiring is not properly secured prior to entering the electrical box. Fastening is required at least within 12" of the box. [various locations in basement noted] Recommend repair.

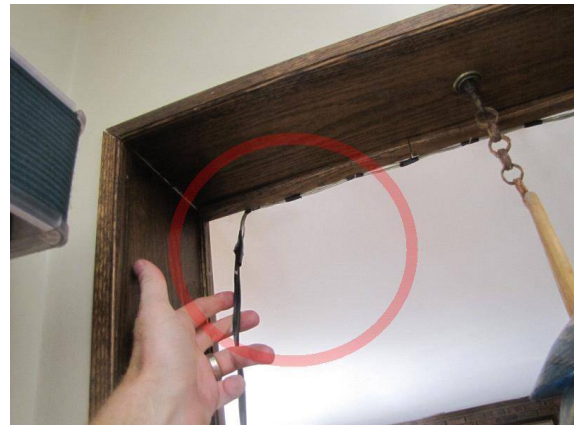
Electrical branch wiring appears to be unsafe. [kitchen light fixture wiring] Recommend replacement.

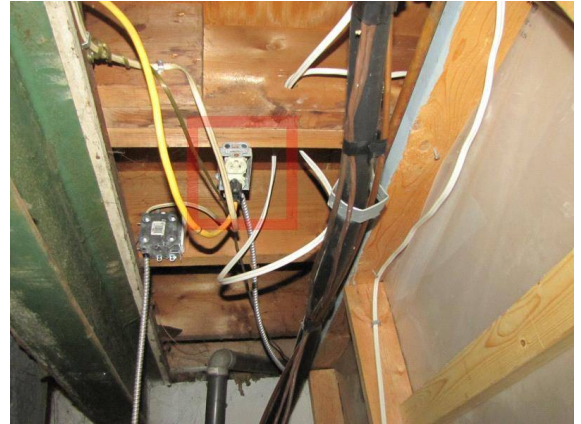
Electrical receptacle cover plate is missing.
[various locations] Recommend Install

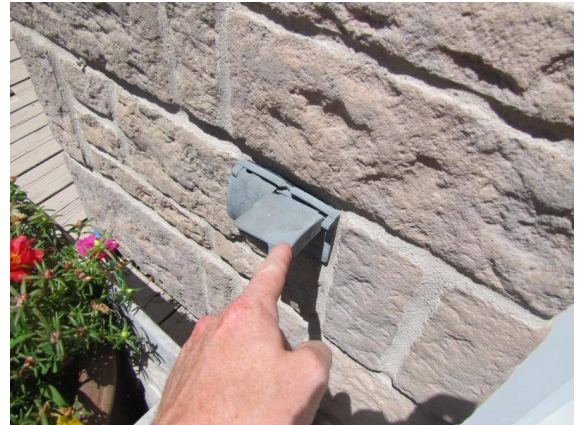
The exterior receptacle is not adequately weather sealed to prevent an electrical short circuit.
[exterior rear outlet] Recommend repair.

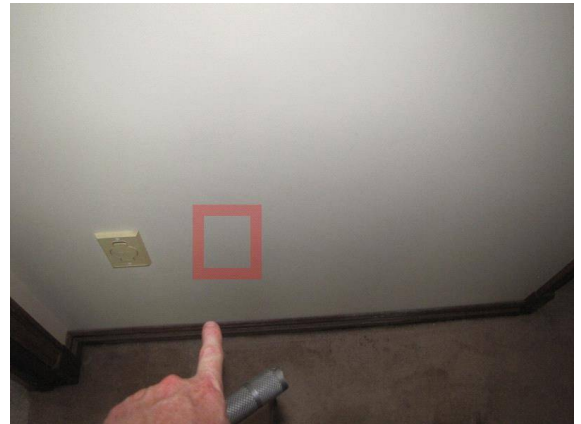
An electrical receptacle has not been installed for the central vacuum system. [several locations] Recommend Install

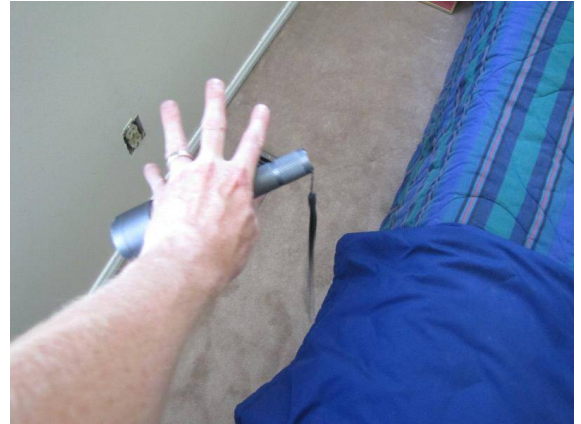
Air Circulation: Little or no air flow observed from the register. [air flow at some 2nd floor bedroom registers was low] These areas may not receive proper climate control. Consult an HVAC specialist for further evaluation and recommended action.

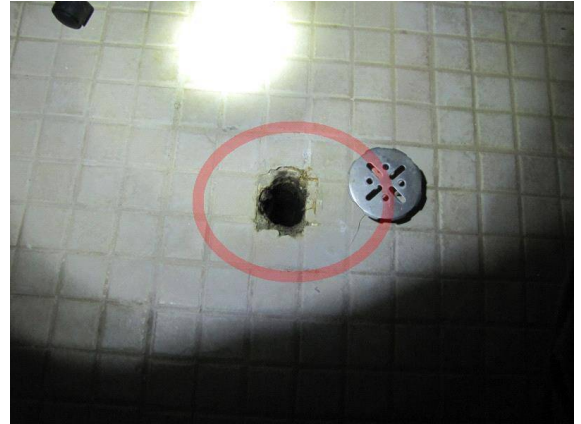
Plumbing waste drainage line installation appears to be of below standard quality and may be prone to failure and subsequent water leakage. [basement shower floor drain] Recommend repair.

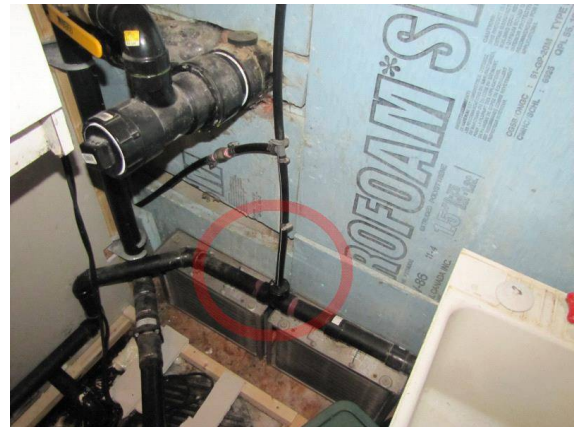
A plumbing trap does not appear to exist for a fixture. [some drainage lines connect directly to the drains without a p-trap] This condition could lead to sewer gases in the house.

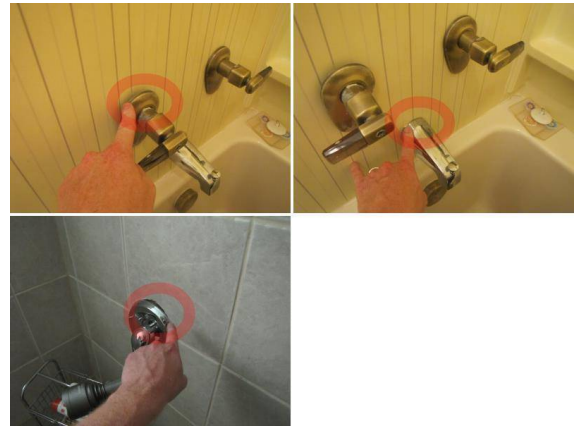
Shower Head: Caulking around showerhead controls and faucet is damaged or missing around the edges. [all bathrooms] Water damage behind surfaces could result. Seal accordingly to prevent future water penetration.

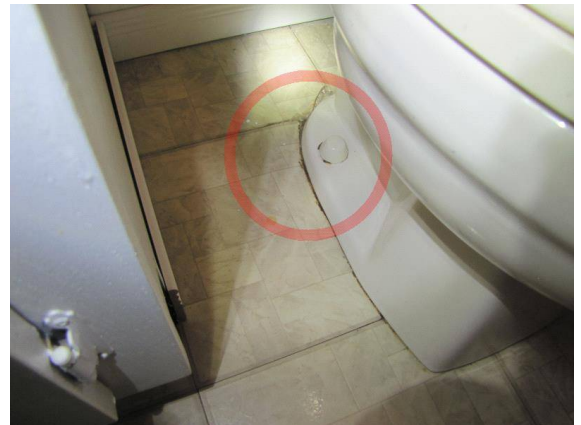
Toilet / Bidet Signs of a previous leak of the toilet. [2nd floor main bathroom - rot and staining around the toilet] At the time of inspection, it could not be confirmed if the problem had been properly corrected so that it would not reoccur.

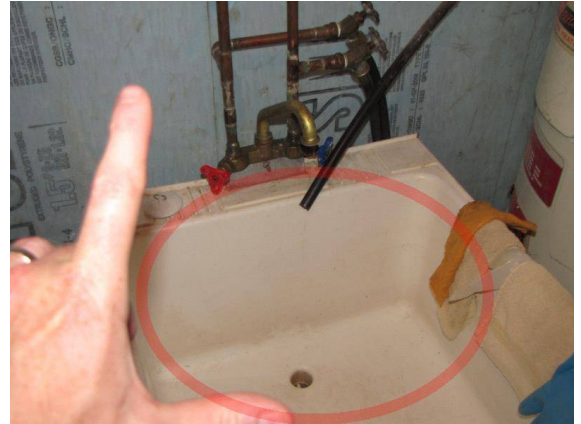
Sinks & Basins: Sink or basin is not securely in place. [laundry room sink] Movement may cause water leakage from pinched or broken pipes.

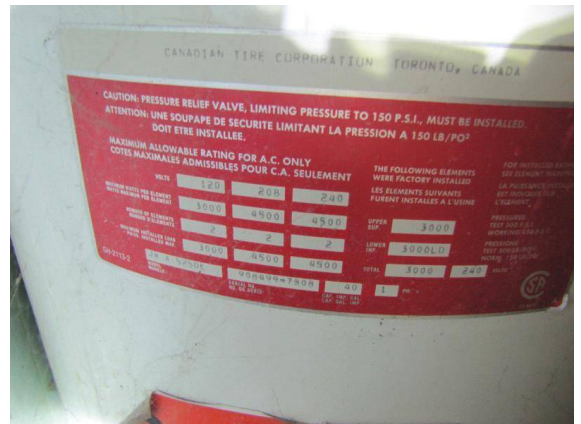
Hot Water Heater: Based on a 12-15 year average life expectancy of most hot water heaters, this unit is near or has reached the end of its life expectancy.

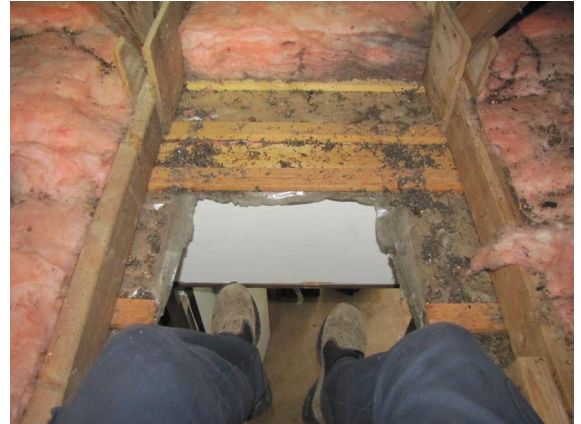
The depth of insulation measured in the attic appears to be less than the depth required achieve current minimum intended R-value thermal barrier, however, it was an acceptable level at the time of installation. This condition could result in higher than necessary utility costs.

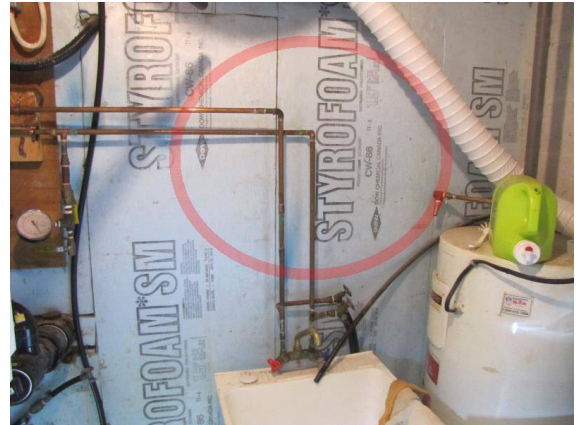
Foundation Wall: Exposed plastic or foam wall insulation. [various unfinished areas] This condition is a potential safety hazard in a fire if not concealed. Recommend repair.

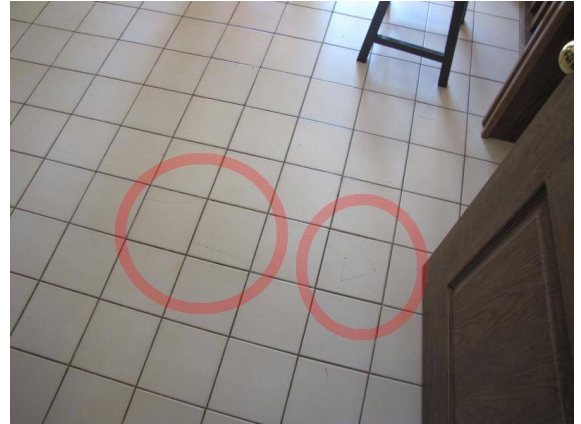
Interior floor crack(s). [kitchen floor tiles are cracked in various locations] Recommend repair.

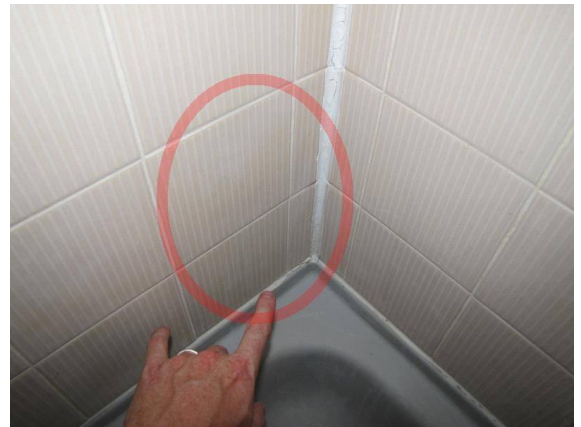
Bathtub & Shower Walls: Bathtub or shower enclosure has visible water damage. [master ensuite shower] This condition may promote mildew or mould growth in the concealed area. Recommend replacement.

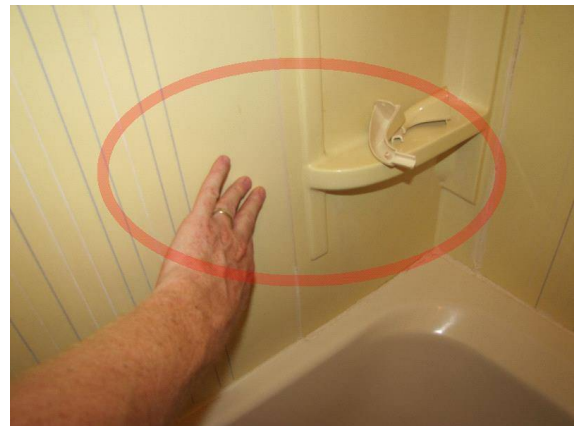
Loose plastic surround in bathtub or shower enclosure. [2nd floor main bathroom] This condition could lead water damage behind the surface. Recommend replacement.

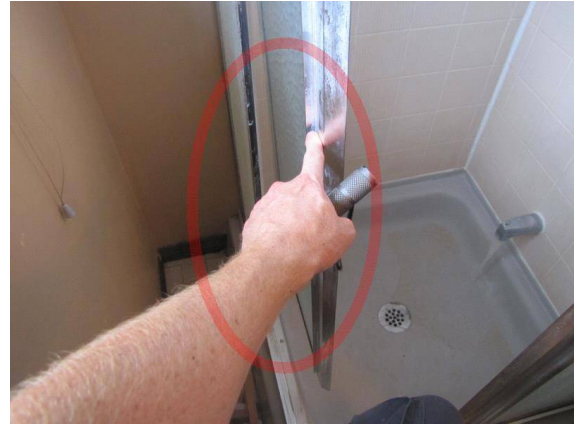
Bathtub or shower enclosure damage/defects.
[master ensuite shower doors are loose]
Continuation of this condition could lead to water damage. Recommend repair.

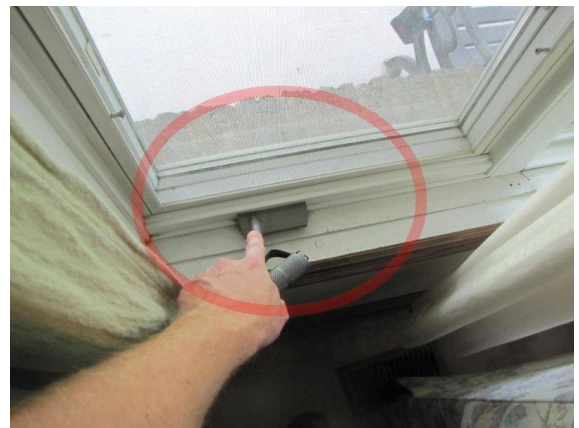
The window open operation is defective. [main floor front window] Recommend repair.
