HOME INSPECTION REPORT

123 ANYWHERE LANE, SPRINGFIELD

06/26/2013

Work Request: Pre-Purchase Inspection.

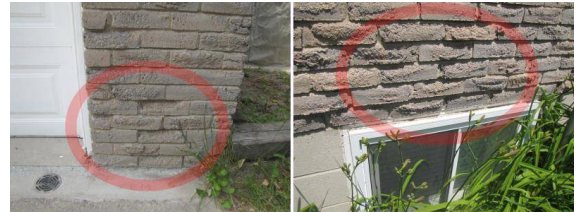
Exterior brick/stone wall cladding step crack(s).
[right side of garage near ground, left side over
basement window] Recommend repair.

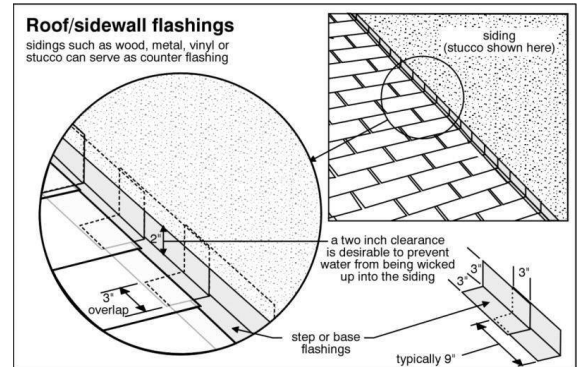
Siding: Stucco/Wood cladding appears to be too close to the roof surface. [where wall cladding meets lower roof] A clearance of 2" is typically required to prevent potential water damage. Monitor this item for continuing changes in condition which may indicate the need for further evaluation by an specialist.

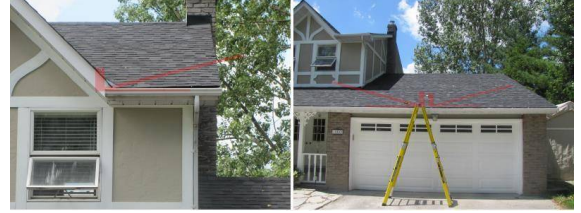
Drainage Systems: The gutter does not appear to be properly sloped towards the downspout which could cause overflow under heavy rain conditions. [front over garage, upper front roof on right side] This, in turn, could cause water damage. Recommend repair.

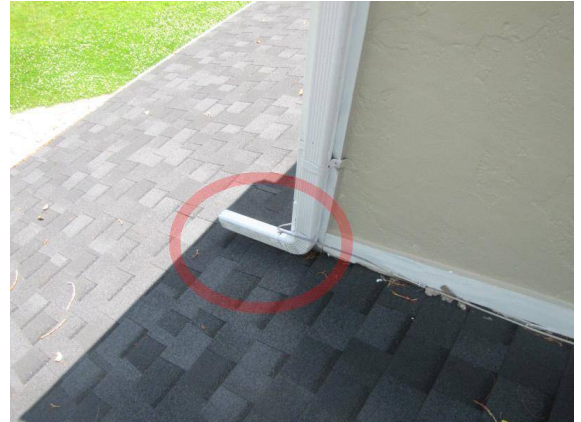
The downspout drainage discharges water directly onto the roof surface which could cause accelerated deterioration of the roof surface overtime. [lower front roof] Extending the drainage directly to a lower gutter or downspout is an option to prevent deterioration.

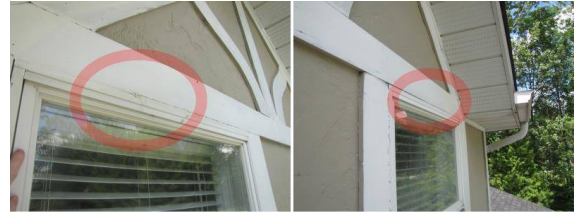
Drip edge missing over windows. [some upper window locations] Water may penetrate around window. Consult a window specialist for further evaluation and recommended action. Recommend Install.

Window Exterior: Drip edge missing over windows. [some upper window locations] Water may penetrate around window. Consult a window specialist for further evaluation and recommended action. Recommend Install.

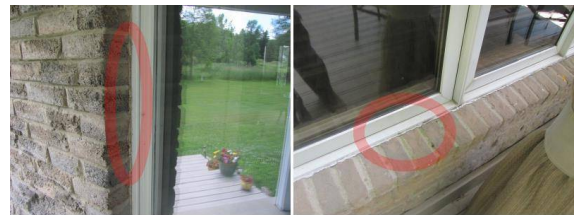
The caulking seal around the window requires maintenance to prevent water penetration and air leakage. [various locations] Seal accordingly to prevent future water penetration.

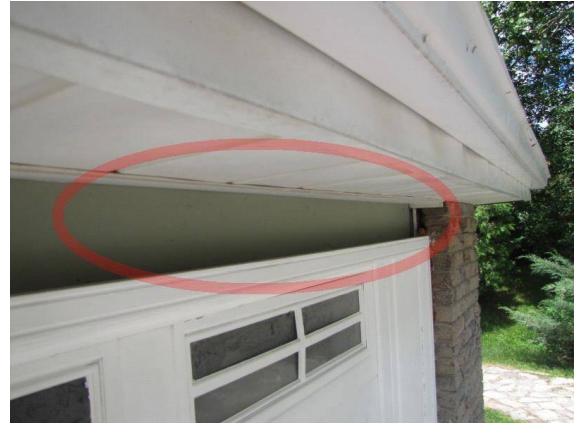
Inadequate flashing around the door/window which may result in water penetrating these areas causing damage. [over garage door] Recommend repair.

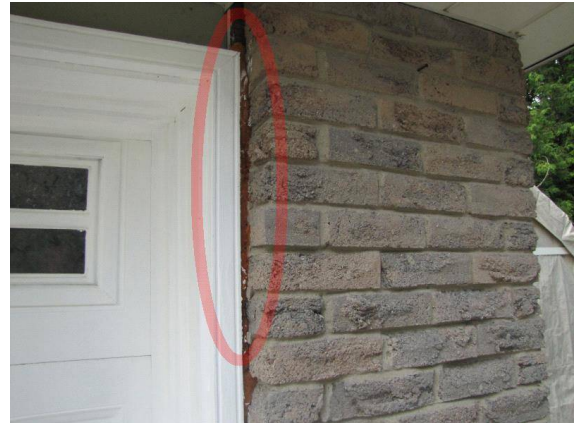
Exterior trim requires sealing around the joints and openings to prevent water penetration and air leakage. [garage door trim] Seal accordingly to prevent future water penetration.

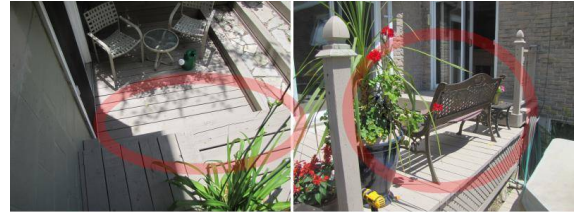
Missing handrail or guardrail is an unsafe condition. [left side of front porch, various areas around rear deck] Recommend Install

Handrail/Guardrail Missing handrail or guardrail is an unsafe condition. [left side of front porch, various areas around rear deck] Recommend Install

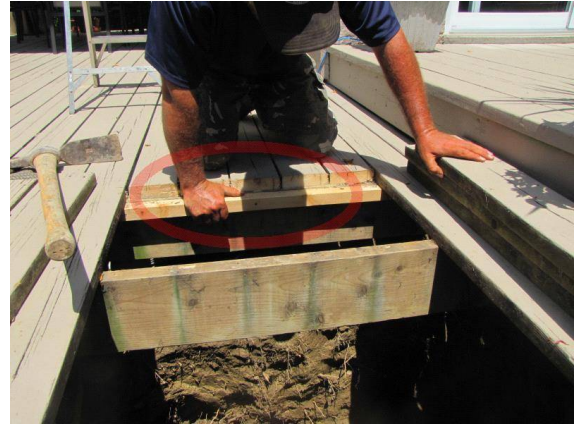
Wood installed over septic tank is untreated and may rot. Deck board support may become compromised. Recommend repair.

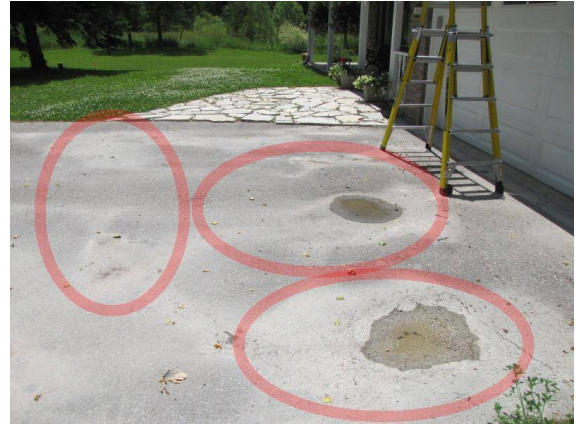
The driveway has sections of unevenness. [various sections of settlement are evident] The decision to take corrective action is discretionary.

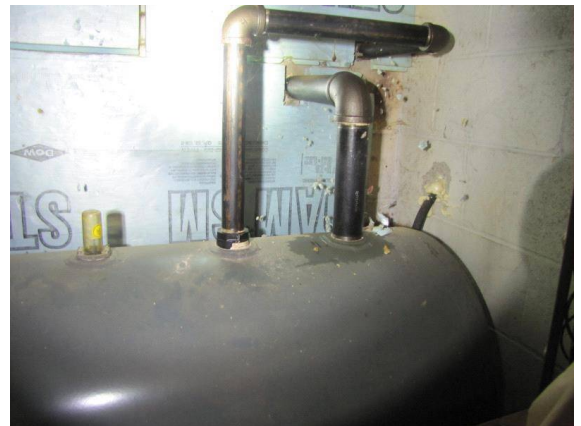
The unknown age oil tank may cause an insurance company to refuse coverage. Confirm eligibility prior to finalizing the purchase agreement.

The age of the oil tank could not be determined. Consult with home owner regarding age of tank. Tanks older than 20 years typically require replacement as a condition of insurance.

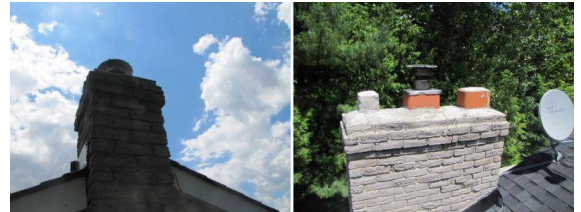
Visible chimney cap crack(s). [both chimneys require minor maintenance] Seal accordingly to prevent future water penetration.

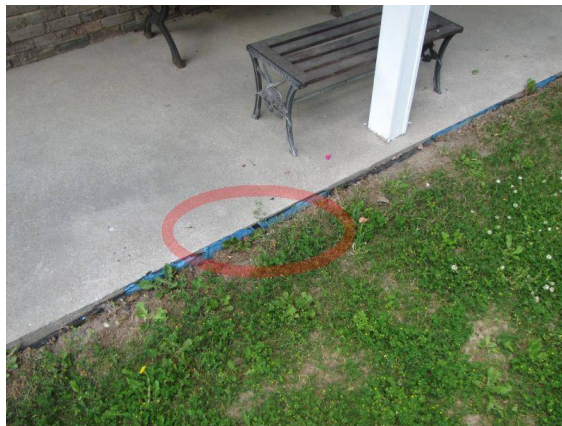
- Foundation Walls (Exterior):** Evidence of water leakage repairs to the foundation wall. [front of porch] Inquire with vendor regarding known history of problems with this area or item.

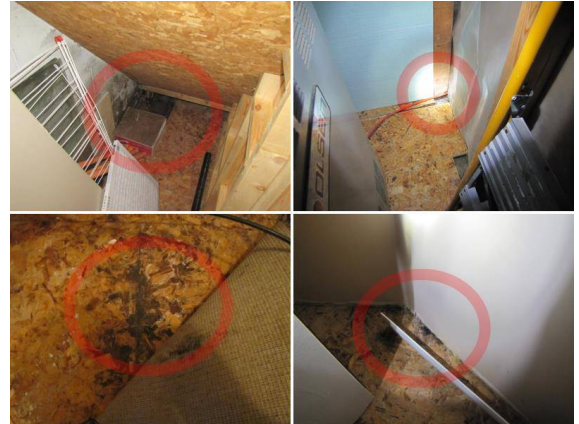
Active water penetration Suspected through the foundation wall/floor. [Front wall of converted cold cellar, under basement stairs, behind furnace & laundry machines] Seal accordingly to prevent future water penetration. Continuation of this condition could lead to water damage. Continuation of this condition may lead to mould growth. Consult a basement water proofing specialist for further evaluation and recommended action.

Foundation Walls (Interior): Active water penetration Suspected through the foundation wall/floor. [Front wall of converted cold cellar, under basement stairs, behind furnace & laundry machines] Seal accordingly to prevent future water penetration. Continuation of this condition could lead to water damage. Continuation of this condition may lead to mould growth. Consult a basement water proofing specialist for further evaluation and recommended action.

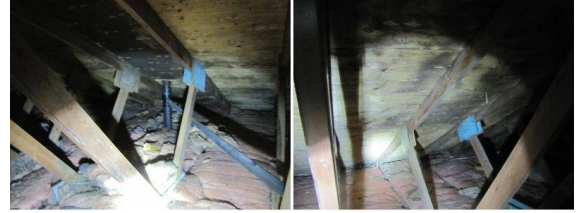
Mildew/mould or similar substance on the surface of the attic roof deck suggests a heat loss condition from the space below creating condensation in the winter. This substance can potentially degrade the indoor air quality if not removed. Ventilation and/or insulation systems may require correction.

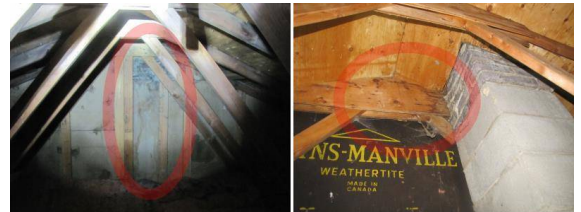
Water marks or similar signs in the attic suggests a previous occurrence of water penetration. [main attic near chimney, garage attic near chimney] Continued water penetration may be possible if the source of the water has not been determined and corrected.

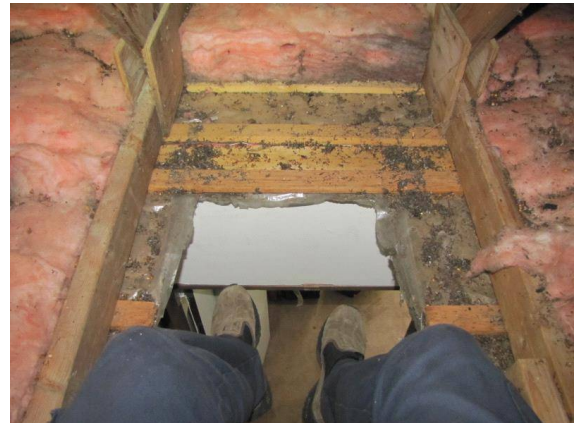
Large amount of dead insects in attic. May form a health hazard. Consult a pest specialist for further evaluation and recommended action.

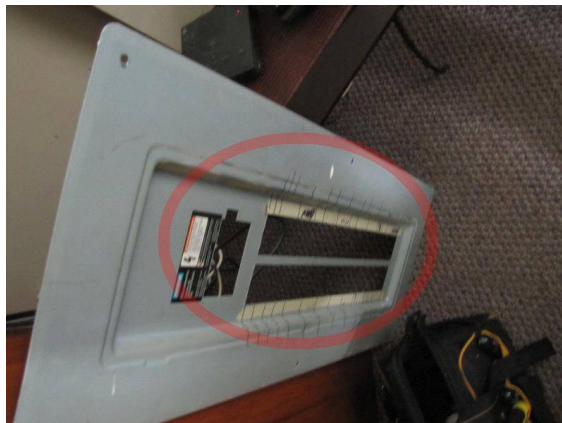
Panel: Inadequate labeling of the electrical panel circuits. It may be difficult to determine the correct shutoff breaker or fuse under an emergency condition. Recommend repair.

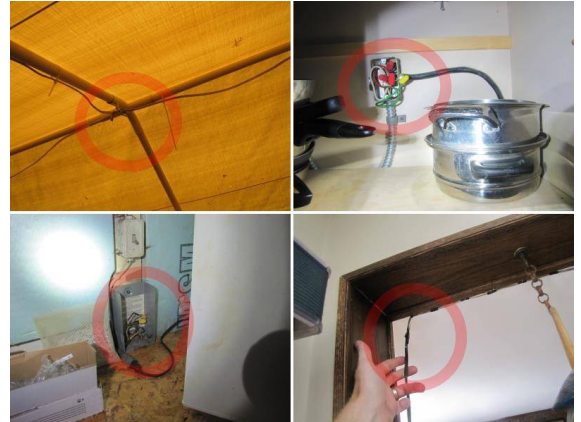
Exposed loose electrical high voltage branch wiring ends or splices must be enclosed in a junction box to prevent accidental contact. [right side shed, kitchen light, water pump wiring] This is a potential safety hazard. Recommend repair.

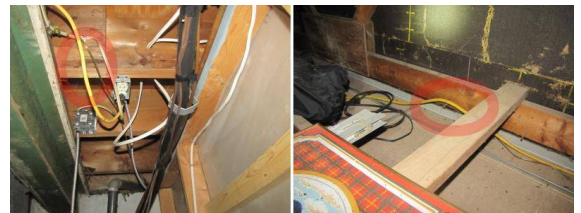
An extension cord is not acceptable as part of a permanent configuration. [basement, garage] Deterioration overtime is possible. Recommend Removal

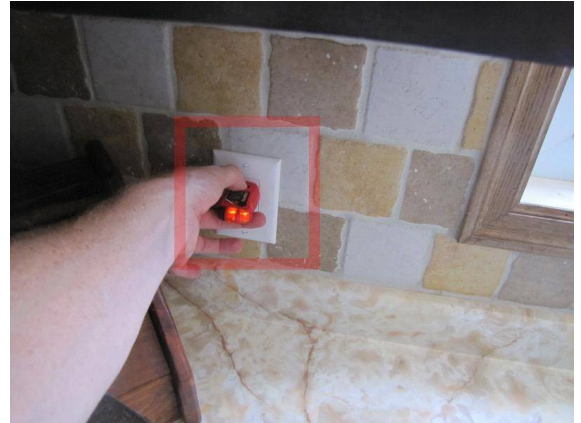
Although not required at the time the house was built, a two pole Ground Fault Circuit Interrupter (GFCI) breaker is now a recommended replacement safety device for the kitchen receptacle due to the close proximity to a water source. This will ensure that this area meets current electrical safety standards. [kitchen counter outlets near sink] Recommend Install

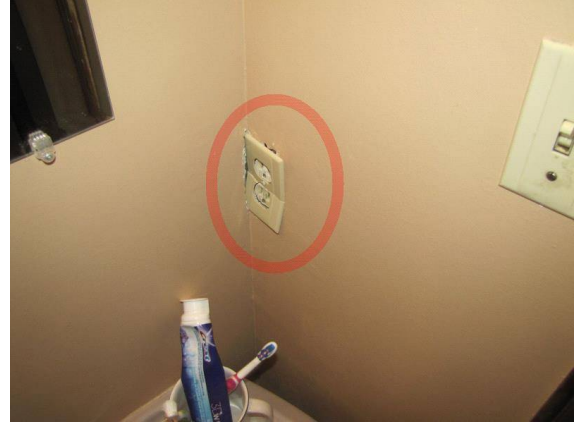
Electrical receptacle does not appear to be safe for use. [master ensuite bathroom] Recommend repair.

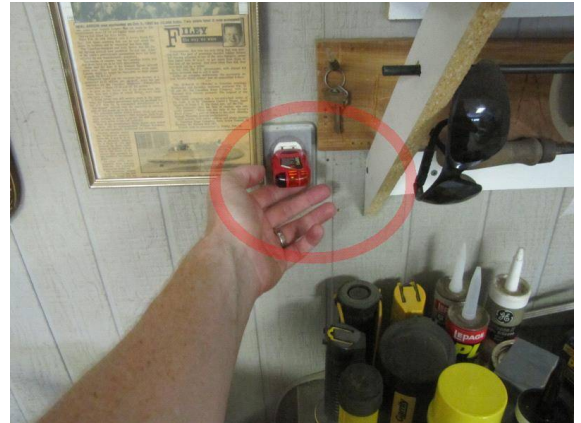
Electrical receptacle did not appear to have power. [rear of garage] Inquire with vendor regarding known history of problems with this area or item.

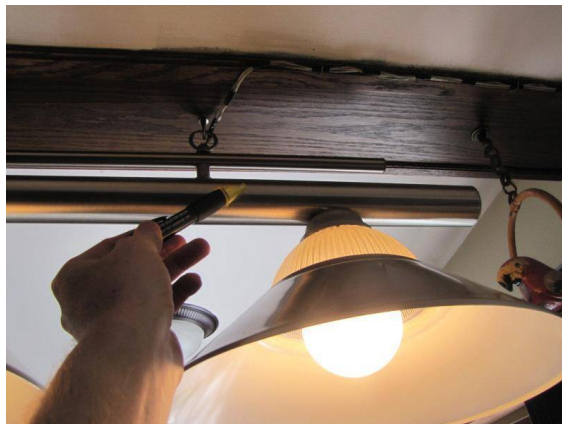
Light fixture ground connection appears to be loose. [kitchen light fixture] This is a potential safety hazard. Recommend repair.

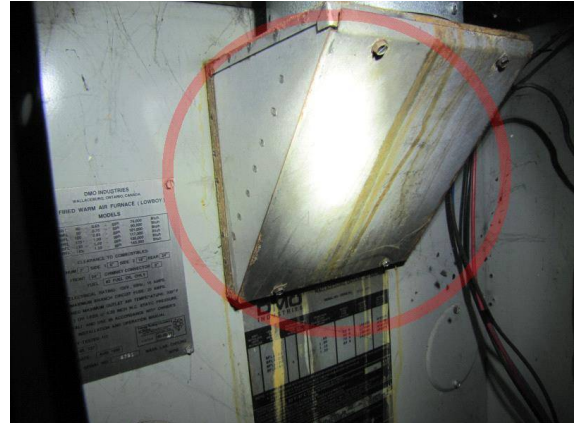
Exhaust System: Exhaust pipe corrosion and staining may indicate improper venting. Consult an oil furnace specialist for further evaluation and recommended action.

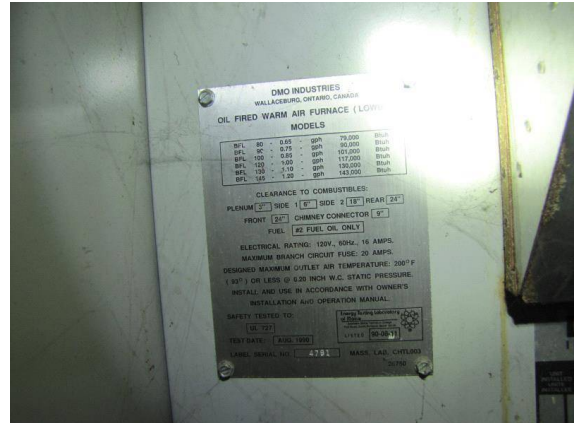
Heating Life Expectancy: Based on historical statistics, the heating system may be near or at end-of-life expectancy. Typical life expectancy are 15-20 for a force air furnace. Schedule service maintenance by a licensed expert to assess the condition of the internal components, heating efficiency and estimated remaining life of the unit / Budgeting for a furnace replacement may be required.

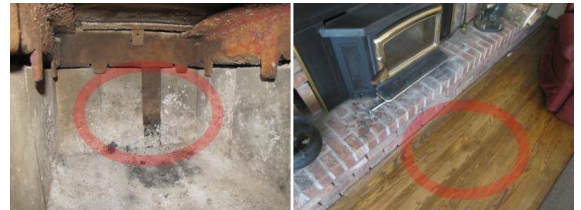
Wood Stove: Wood stove floor protection appears to be missing. It is required to protect the floor from the excessive radiant heat that could cause fire. Consult a WETT specialist for further evaluation and recommended action.

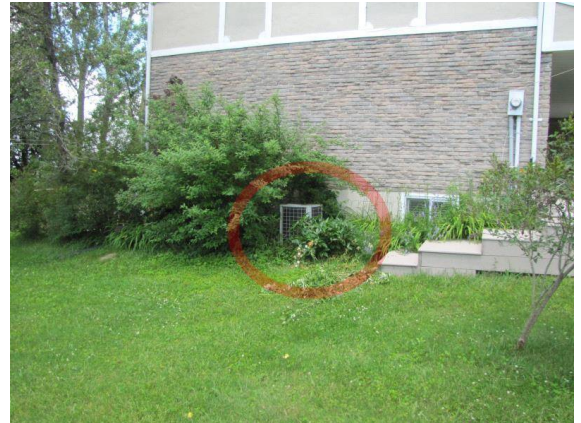
Condenser & Compressor: Excessive foliage around the cooling system outdoor unit. The unit may not operate efficiently and operation may fail over time due to overheating. Provide adequate ventilation.

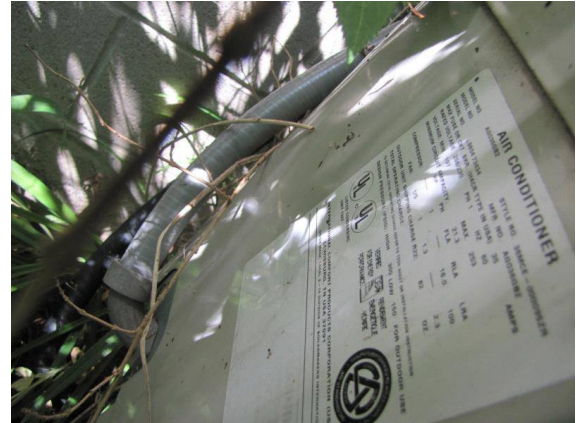
Life Expectancy: Based on a 15 year average life expectancy of most central air conditioners, this cooling unit may be near or has reached the end of its life expectancy. Schedule service maintenance by a licensed expert to assess the internal components, cooling efficiency and estimated remaining life of the unit.

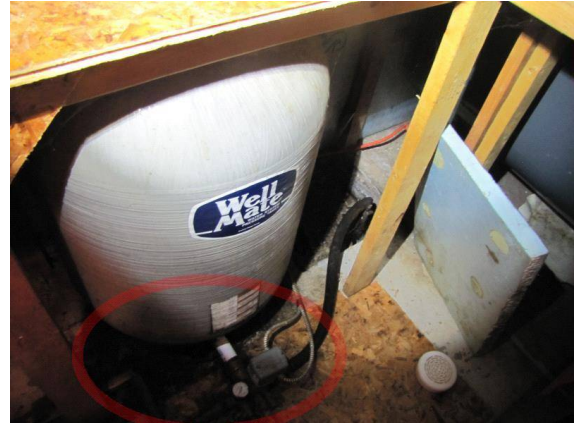
Visible water and staining on floor indicates a potential ongoing minor leak in the well equipment room. Monitor this item for continuing changes in condition which may indicate the need for further evaluation by a specialist.

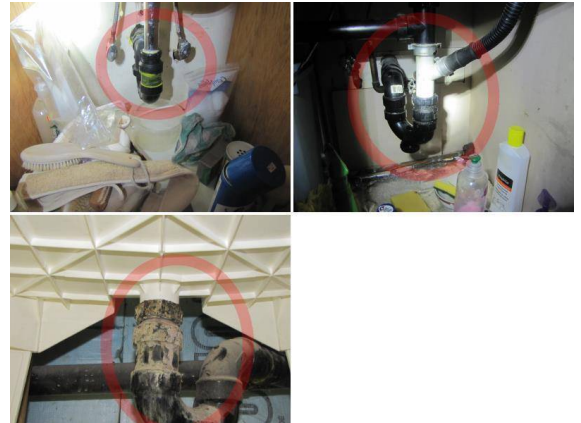
Signs of a previous leak in the plumbing waste drainage pipe. [2nd floor bathroom sink, kitchen sink drains, laundry room sink] At the time of inspection, it could not be confirmed if the problem had been properly corrected so that it would not reoccur. Monitor this item for continuing changes in condition which may indicate the need for further evaluation by a specialist.

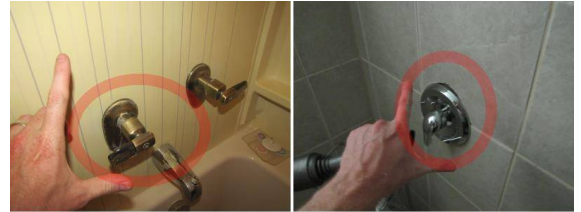
Faucet (Interior): The faucet is not securely in place which could lead to water leakage. [2nd floor main bathroom, basement shower] Recommend repair.

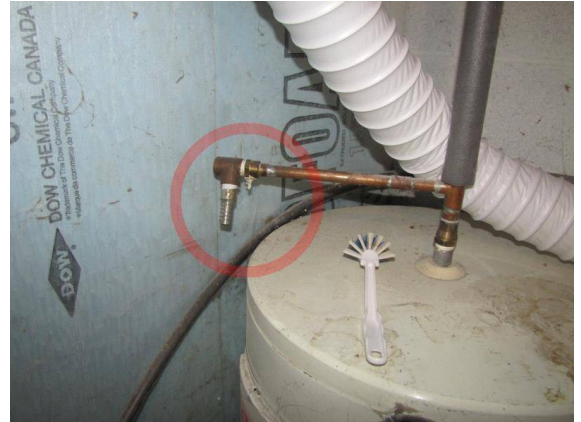
Hot water heater pressure relief valve drain line pipe is missing. Scalding hot water automatically discharged through the drain line would be a safety hazard to people nearby. Recommend Install

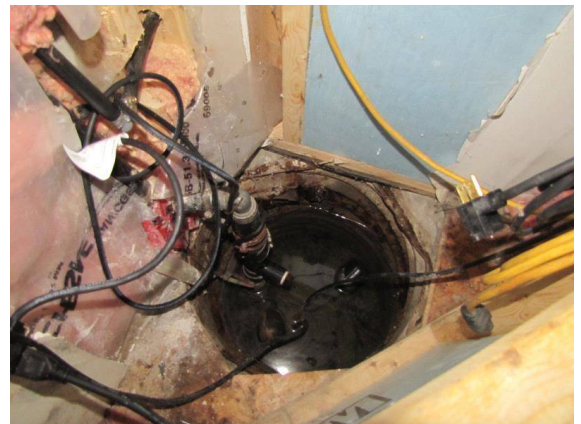
Sump:

Sump opening is not covered. Excessive moisture from the exposed water may damage surrounding structures and property.

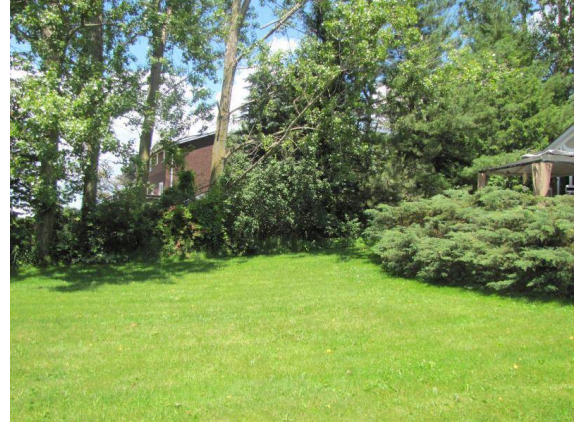
Septic:

Trees and/or foliage may be too close to septic tile bed and could potentially cause damage. Consult a septic system specialist for further evaluation and recommended action.

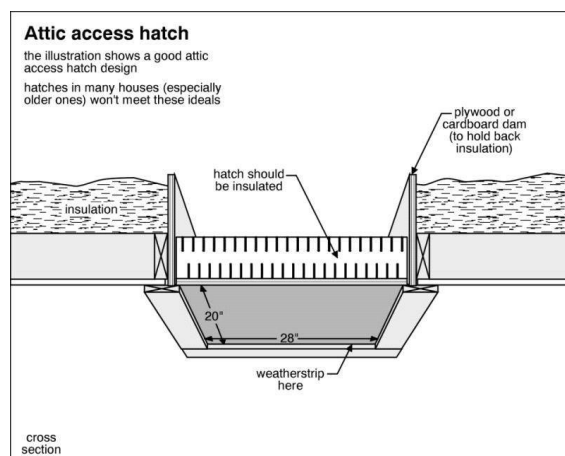
- Attic:** Attic hatch may be a point of heat lose which could result in mould growth around the hatch entry area. Foam weather stripping around the underside edges of the hatch cover and foam insulation on the top side of the cover will prevent heat lose. Recommend repair.

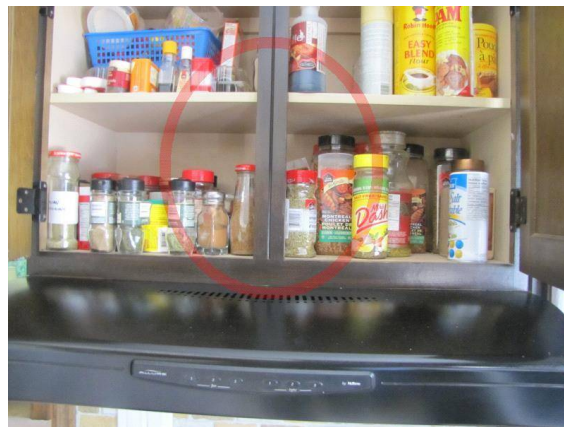
Kitchen: Kitchen exhaust fan appears to vent internally within the kitchen as opposed to outside, but is an acceptable configuration. This configuration will not remove the moisture, but can reduce odors as long as a charcoal filter is inserted above the standard filter. Otherwise, the odors will just re-circulate within the kitchen.

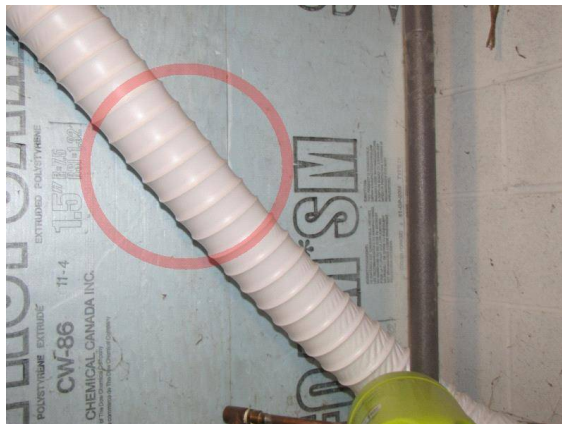
The plastic-based dryer vent pipe may be susceptible to catching fire under high heat conditions. A metal based vent pipe is a safer option for this installation.

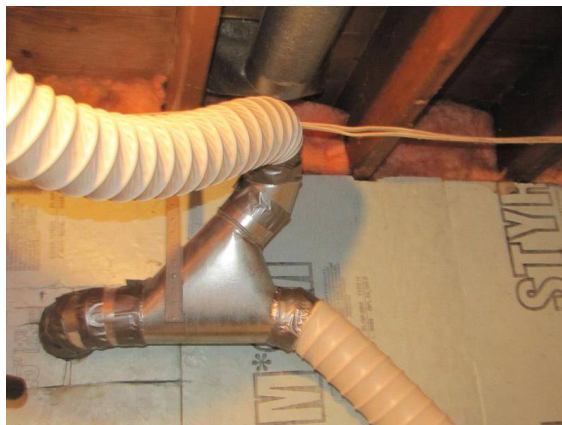
The dryer shares the same ventilation pipe as another appliance which is not an acceptable configuration. [joined with basement bathroom] When both are operating, the weaker vent will not be able to effectively ventilate.

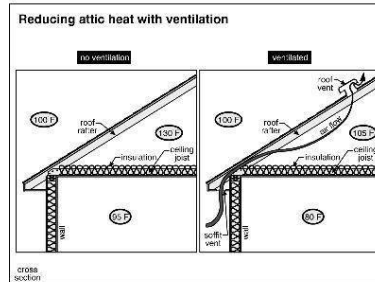
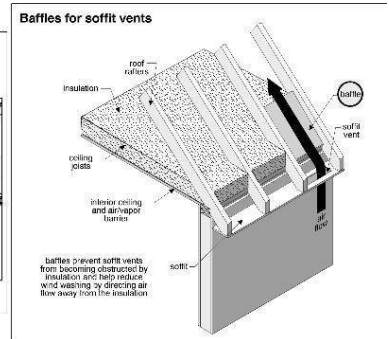
Roof: Soffit vent or baffle may be blocked which could restrict natural flow of air in and out of the attic. That conditions could potentially result in moisture accumulation, and mildew/mould growth in the attic. Also, heat buildup in attic could melt the snow on the roof leading to ice damming conditions which can cause water damage to the house.

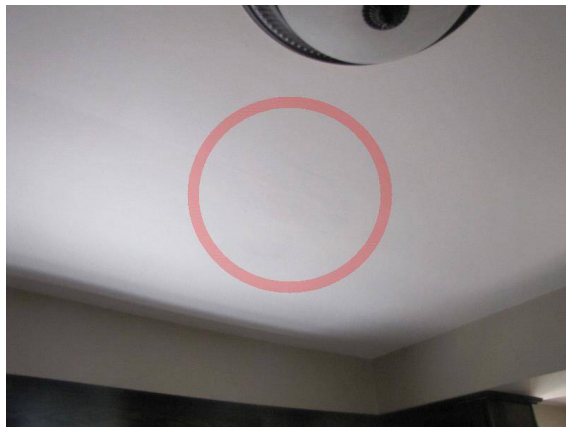
Ceilings: Evidence of repairs to the interior ceiling. [kitchen ceiling] Inquire with vendor regarding known history of problems with this area or item.

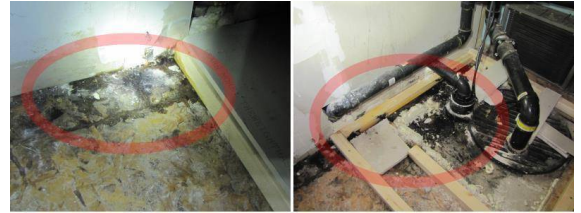
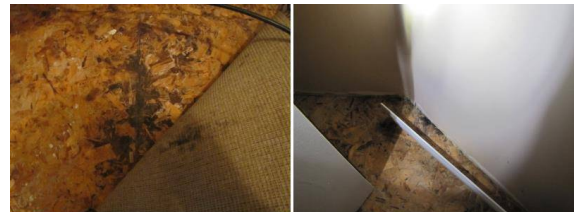
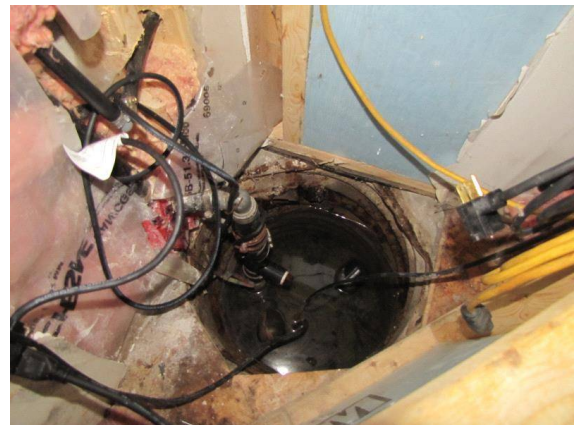
Walls:

Interior wall mildew or mould. [around sewage ejector pump, front wall of basement, right wall of basement, around sump pump enclosure] Consult a mould specialist for further evaluation and recommended action.

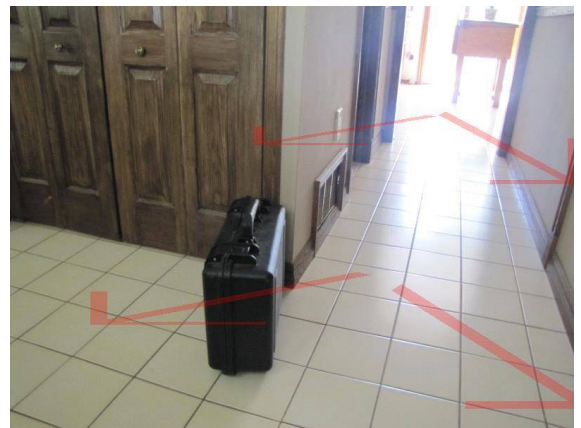
Interior floor unevenness. [slope noted in main floor hallway] This condition does not appear to be significant in nature.

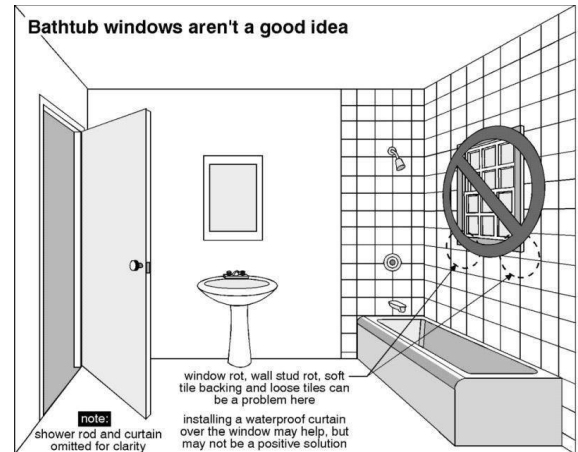
Window located within shower enclosure may be susceptible to water damage if not properly maintained. [basement shower] Monitor the condition of the seals frequently.

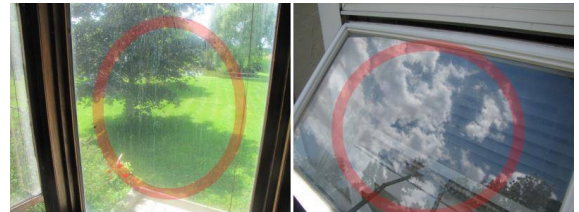
A broken seal in the window has resulted in moisture accumulation between the panes of glass. [most windows in the house have blow seals] In many cases, this condition can progress to the point where viewing through the window is difficult. Also, the energy efficiency of the window may be significantly reduced. Recommend replacement.

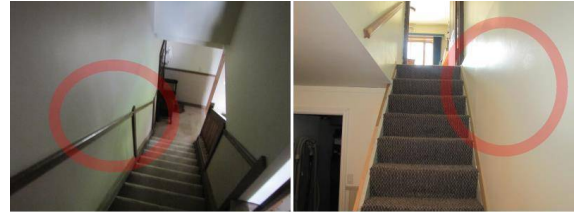
Handrail/Guardrail Missing handrail or guardrail is an unsafe condition. [2nd floor stairs, basement stairs]
Recommend Install
